PQSoft Case Study

Distribution System Transient Measurement Data Evaluation

Document ID:	PQS1012	Date:	October 15, 2010
Customer:	N/A	Status:	Completed
Author:	Electrotek Concepts, Inc.	Access Level	PQSoft Subscriber

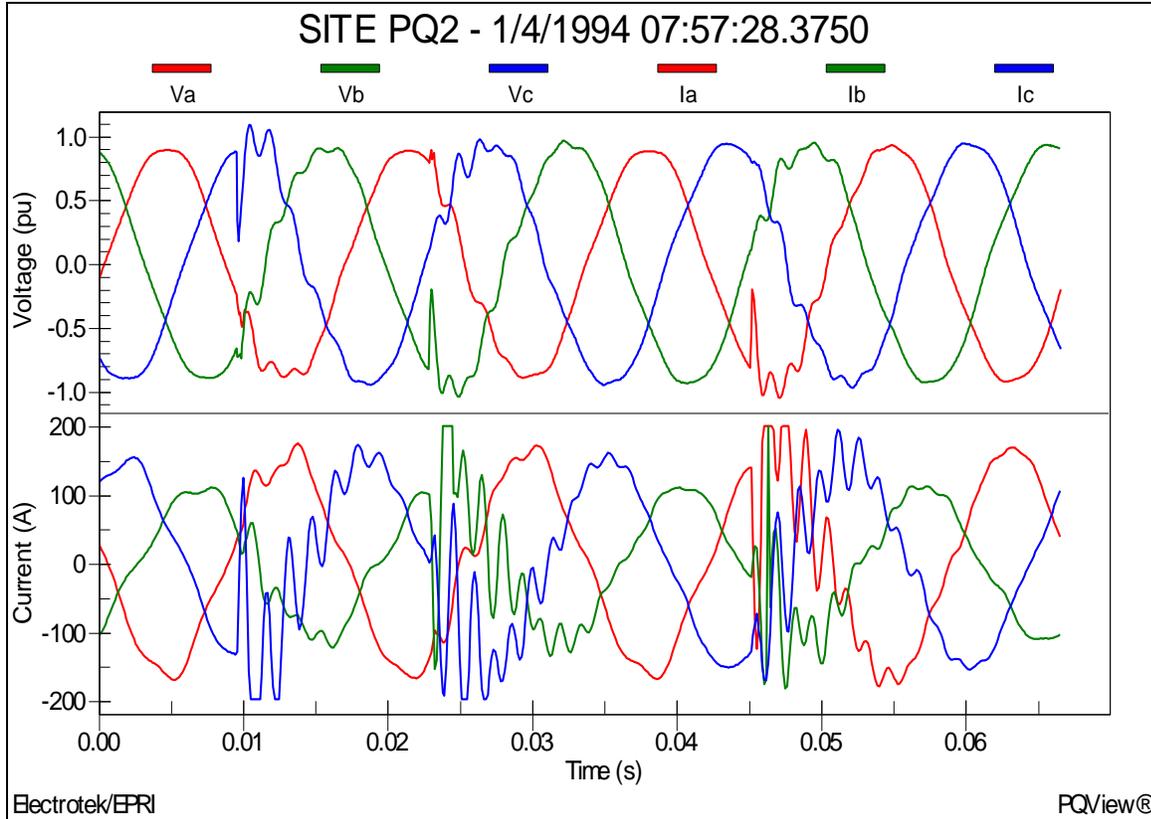
Figure 2 - Illustration of Feeder Capacitor Bank Energizing

Figure 2 shows the measured voltage (per-unit) and current (A) waveforms during uncontrolled energization of the pole-mounted 600 kVAr capacitor bank on feeder #1. The measurement site was PQ2. The capacitor bank was switched on-and-off each day using time clock controls in an attempt to maintain a relatively constant voltage profile. The peak magnitude of the measured transient voltage was 1.09 per-unit and the principal frequency for the capacitor energizing waveform was approximately 650 Hz. The capacitor bank was energized using three single-phase mechanical oil switches with a pole span of approximately 3-5 cycles.

Typical voltage magnitude levels for switching distribution capacitor banks range from 1.3 to 1.5 per-unit and typical transient frequencies generally fall in the range from 300 to 1000 Hz. Power quality problems related to utility capacitor bank switching include customer equipment damage or failure, nuisance tripping of adjustable-speed drives or other process equipment, transient voltage surge suppressor failure, and computer network problems.

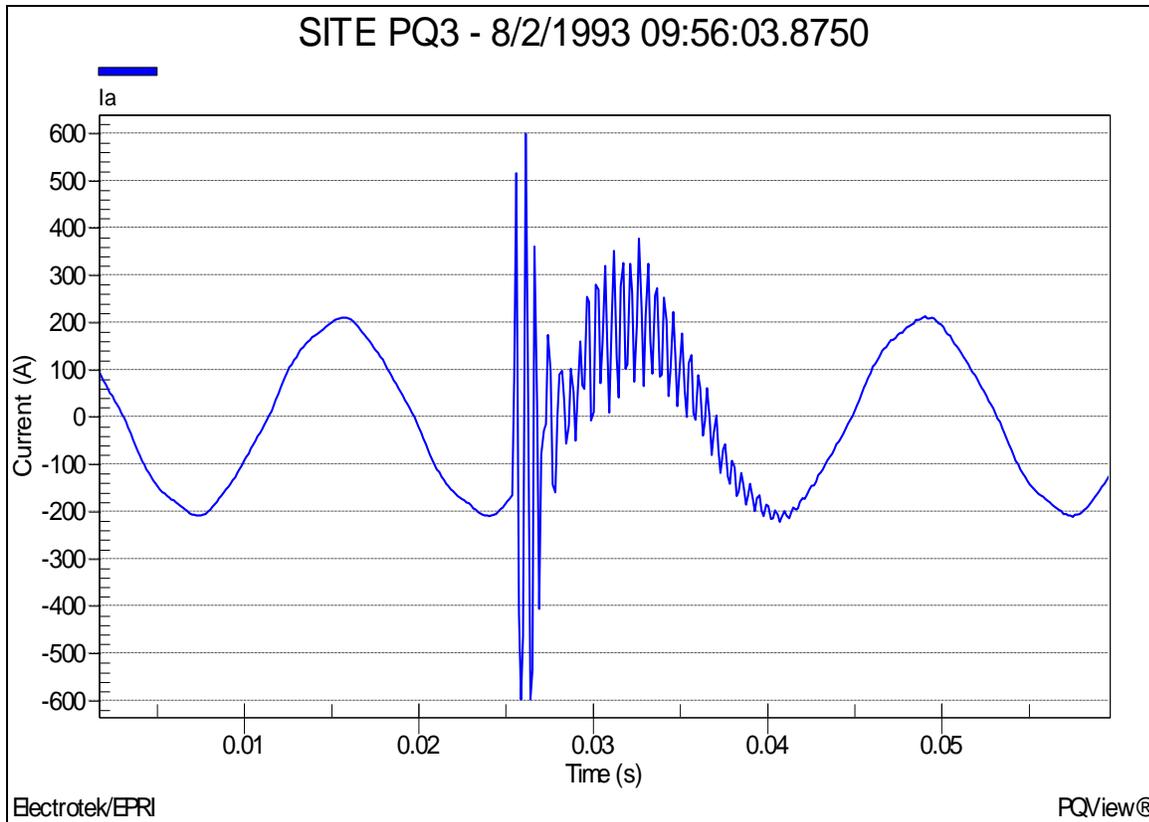
Figure 3 - Illustration of Back-to-Back Capacitor Bank Energizing

Figure 3 shows the measured current waveform during back-to-back capacitor bank switching on feeder #2. Energizing a shunt capacitor bank with an adjacent capacitor bank already in service is known as back-to-back switching. High magnitude and frequency currents will flow between the capacitor banks when the second capacitor bank is energized. The measurement site was PQ3. The waveform shows the current that flows between the two 1,800 kVAr capacitor banks when the second capacitor bank is energized with the first capacitor bank already in service. The magnitude of the peak current was 600 A and the principal frequency was about 2.0 kHz.

The high-frequency inrush current may exceed the transient frequency momentary capability of the switching device (e.g., ANSI Std. C37.06-2000) as well as the I^2t withstand of the capacitor fuses. It may also cause false operation of protective relays and excessive voltages for current transformers (CTs) in the neutral or phase of grounded-wye capacitor banks

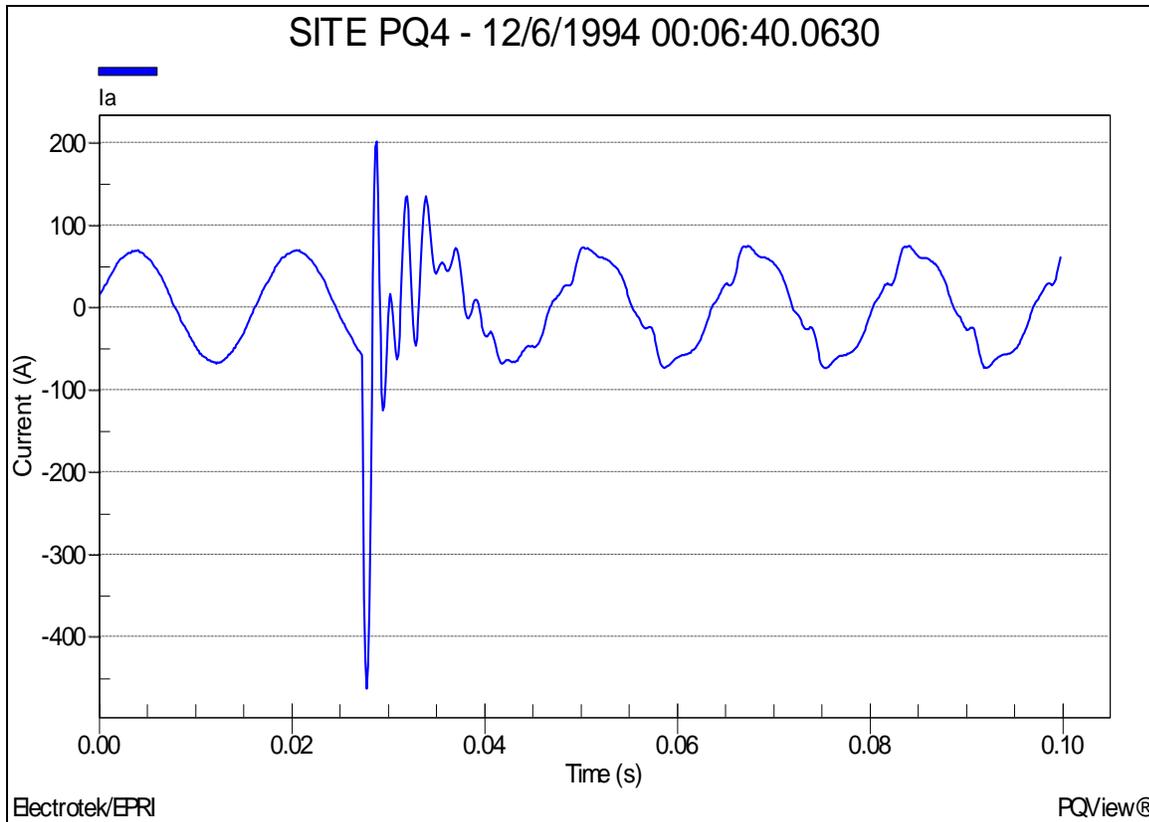
Figure 4 - Illustration of Capacitor Bank Energizing and Harmonic Resonance

Figure 4 shows the measured 12.47 kV distribution feeder current waveform before-and-after energization of the pole-mounted 900 kVAr capacitor bank on feeder #3. The capacitor bank was switched on-and-off each day at the same time using a time clock control. The measurement site was PQ4.

The peak transient current for the capacitor bank energization portion of the event was 460 A. Insertion of the 900 kVAr capacitor bank creates a harmonic resonance that results in higher levels of current distortion. The steady-state total harmonic current distortion (I_{THD}) after energization of the capacitor bank was 13.26%.

Utilities switch capacitor banks in-and-out of service routinely to provide voltage support and to improve power factor. One potential disadvantage of capacitor bank switching is the effect that such an operation can have on the topology of the system. Switching capacitor banks into mostly inductive circuits can tune the natural frequency of the circuit closer to harmonic frequencies that might be prevalent on the system. Obviously, this can be a significant problem, possibly resulting in severe voltage and current distortion, increased losses, and overheating of system equipment.

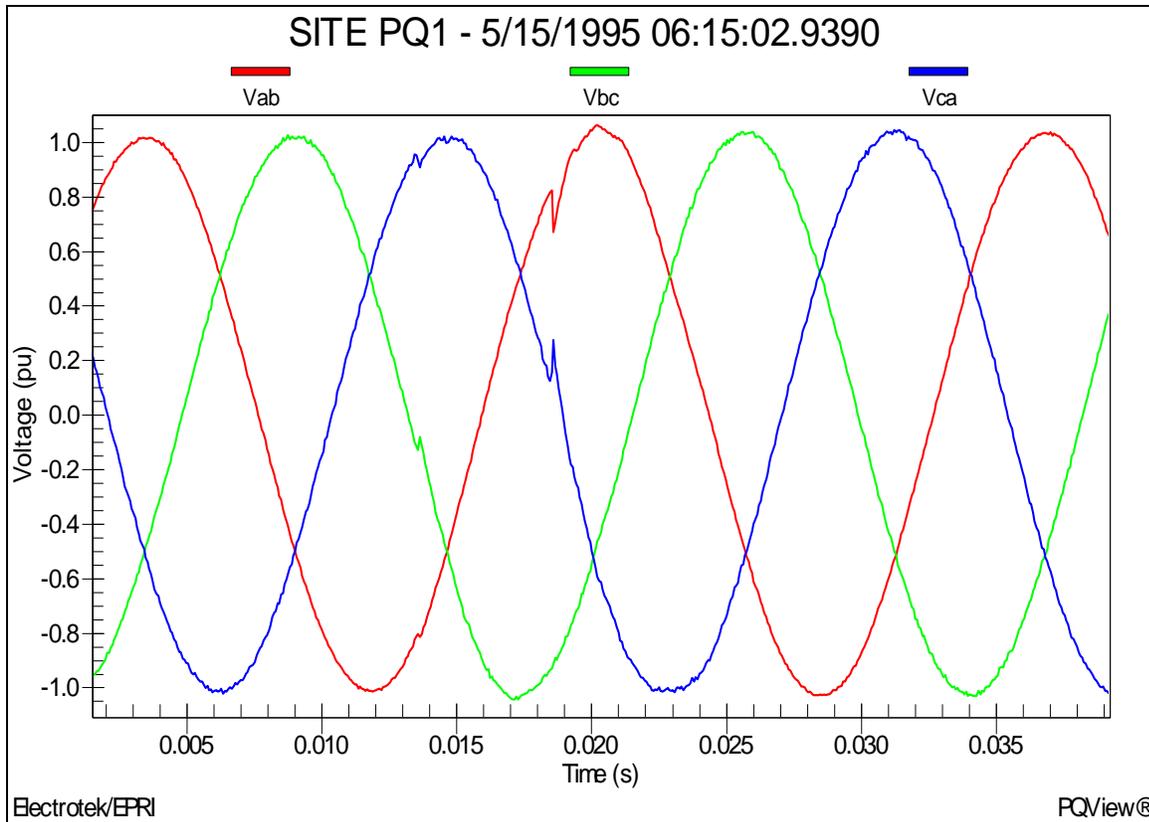
Figure 5 - Illustration of Capacitor Bank Energizing with Synchronous Closing

Figure 5 shows the measured voltage (per-unit) waveforms during energization of the substation 6,000 kVAR capacitor bank on feeder #1. The capacitor bank was switched using synchronous closing control. The measurement site was PQ1. The magnitude of the transient voltage at the substation bus was 1.06 per-unit.

Synchronous closing is independent contact closing of each phase near a voltage zero. To accomplish closing at or near a voltage zero (avoiding high prestrike voltages); it is necessary to apply a switching device that maintains a dielectric strength sufficient to withstand system voltages until its contacts touch. Although this level of precision is difficult to achieve, closing consistency of ± 0.5 milliseconds should be possible. Previous research has indicated that a closing consistency of ± 1.0 millisecond provides overvoltage control comparable to properly rated pre-insertion resistors. The typical transient overvoltage range for synchronous closing control would be between 1.05 and 1.20 per-unit depending on the capacitor bank rating and a number of other system parameters.

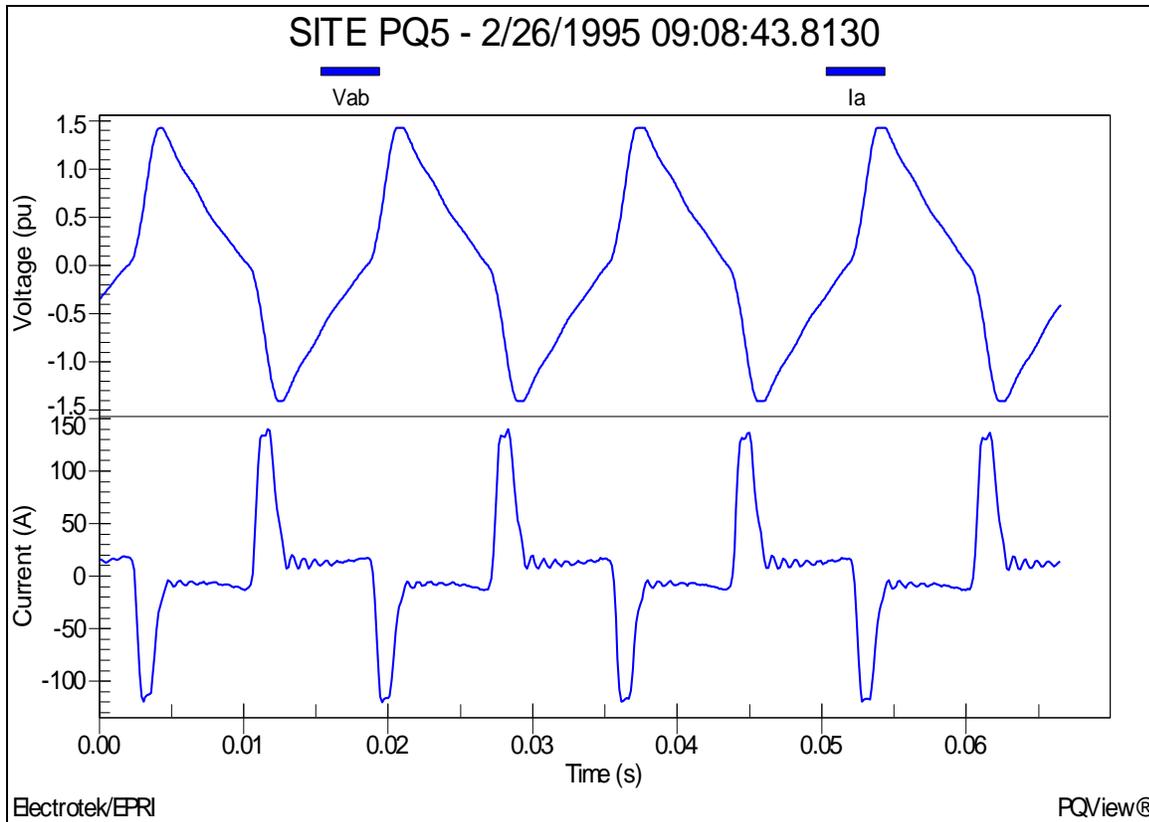
Figure 6 - Illustration of Distribution Feeder Ferroresonance

Figure 6 shows the measured voltage (per-unit) and current (A) waveforms during a ferroresonance event on feeder #4. The measurement site was PQ5. The magnitude of the ferroresonant voltage at the monitoring location was 1.42 per-unit. The cause of the ferroresonance event was an unbalanced operation caused by a single-phase fuse operation on a customer step-down transformer.

Ferroresonance is a term generally applied to a wide variety of interactions between capacitors and iron-core inductors that result in unusual voltages and/or currents. In linear circuits, resonance occurs when the capacitive reactance equals the inductive reactance at the frequency at which the circuit is excited. Iron-core inductors have a nonlinear characteristic and therefore a range of inductance values. This relationship may lead to a number of operating conditions where the inductive reactance does not equal the capacitive reactance, but very high and damaging overvoltages occur.

If high voltages accompany the ferroresonance, there could be electrical damage to both the primary and secondary circuits. Surge arresters commonly fail during this condition. Arrester failures are related to the heating of the arrester block, and at times, the failures can be catastrophic, with parts being expelled from the arrester housing. In a typical power system, ferroresonance occurs when a transformer becomes isolated on a cable section in such a manner that the cable capacitance appears to be in series with the magnetizing characteristic of the transformer. An unbalanced switching operation is required to initiate the condition. Ferroresonance cannot always be entirely avoided. However, steps can be taken to reduce the probability of occurrence.

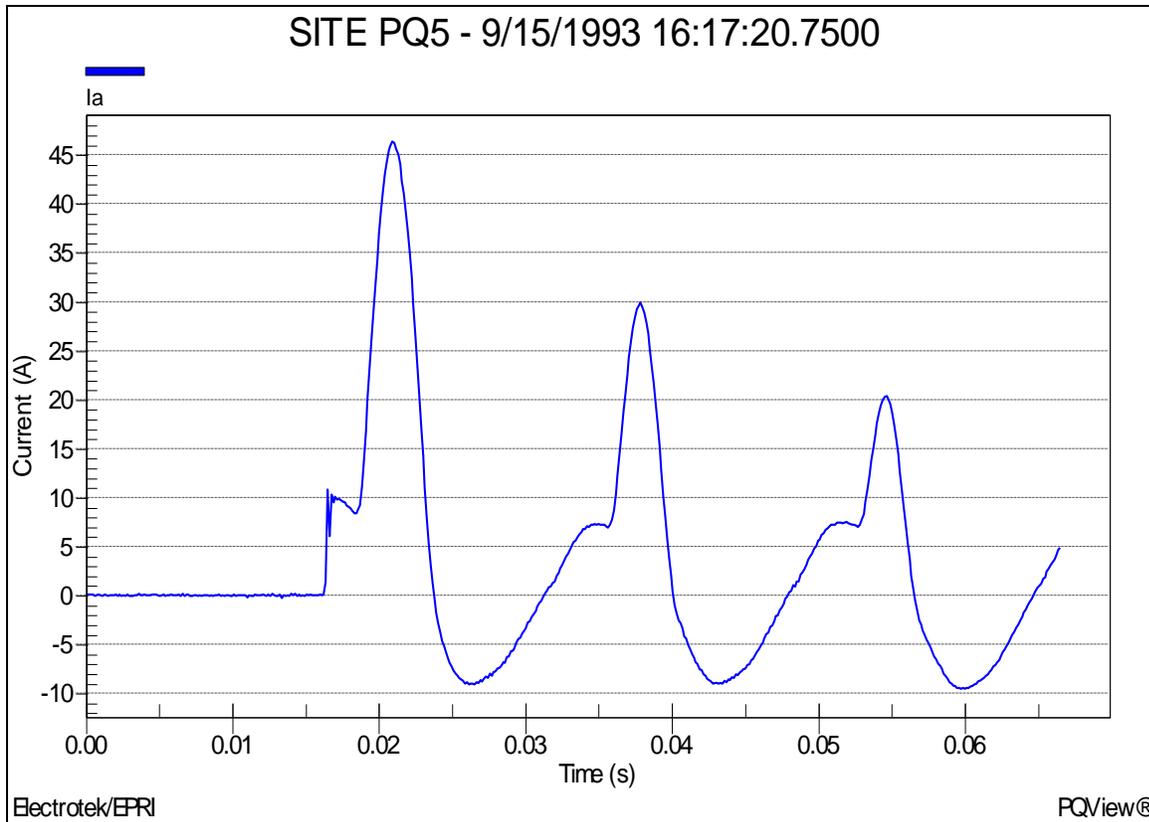
Figure 7 - Illustration of Transformer Inrush during Circuit Restoration

Figure 7 shows the measured current (A) waveform during a transformer energizing event on feeder #4. The measurement site was PQ5. The peak magnitude of the primary inrush current at the monitoring location was 46 A and the duration of the event was approximately 10 cycles. The cause of the transformer inrush was a recloser operation during circuit restoration.

Energizing saturable devices (devices with magnetic cores), such as power transformers, results in inrush currents that are rich in harmonic components. The inrush current interacts with the system impedance vs. frequency characteristics to create a voltage waveform that can have significant harmonic components for the duration that the inrush current is present. Transformer inrush current typically decays over a period on the order of one second.

This phenomenon combines concerns for harmonic current distortion and transient voltages. The harmonics of concern are low order (dominated by the 2nd through the 5th harmonics). If the circuit has a high impedance resonance near one of these frequencies, a dynamic overvoltage condition results that can cause failure of arresters and problems with sensitive equipment.

This problem is typically limited to cases of energizing large transformers with large power factor correction capacitor banks (e.g., arc furnace installations or other large industrial facilities). The solution to problems with dynamic overvoltages is to make sure that the conditions causing the system resonance are not present when the transformer is energized. This could mean making sure a capacitor bank is out of service whenever a large transformer is energized.

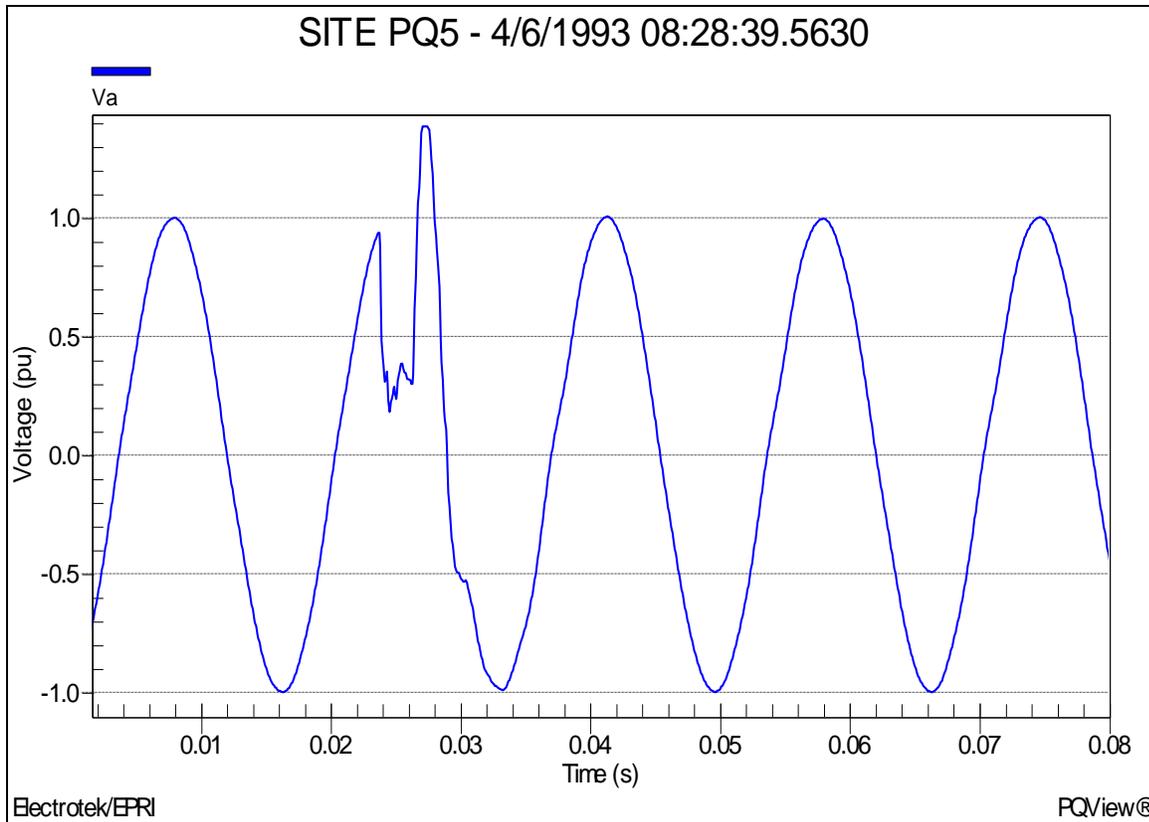
Figure 8 - Illustration of a Current Limiting Fuse Operation

Figure 8 shows the measured voltage (per-unit) waveform during the operation of a current-limiting fuse (type 25K CL) on feeder #4. The measurement site was PQ5. The maximum peak arc voltage for the event was approximately 140% (1.40 per-unit). The fault was cleared by the fuse in approximately $\frac{1}{2}$ cycle.

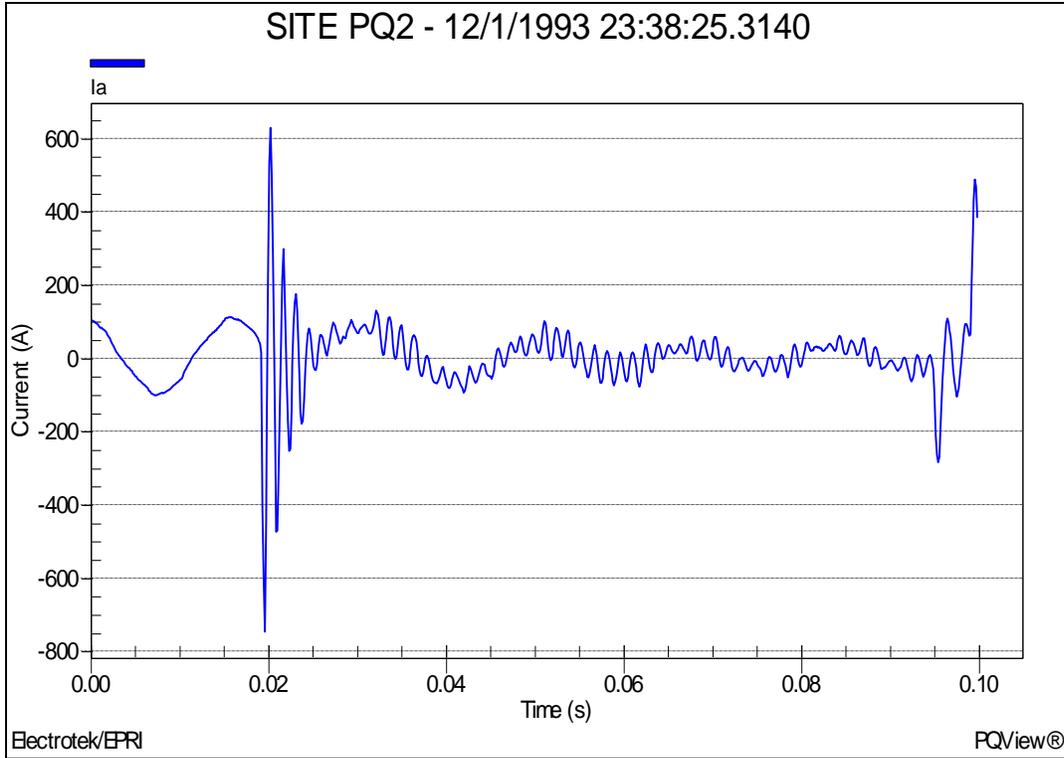
Figure 9 - Illustration of a Current Waveform during an Arcing Fault Event

Figure 9 shows the measured current (A) waveform during an arcing fault on feeder #1. The measurement site was PQ4. The fault occurred during a thunderstorm and it was cleared in approximately 4 cycles by a recloser on an adjacent feeder.

Arcing faults are quite common on distribution and transmission feeders. These types of faults are usually caused by lightning strikes to the circuit, tree limbs contacting the circuit, or animals contacting the circuit. Arcing faults often contain a significant third harmonic component. Consequently, the arcing voltage waveform often has a “flat-top” appearance, resembling a square-wave. The arcing current typically exhibits a continuous ringing. This characteristic can be attributed to the ringing between the system inductance and capacitance as the voltage changes suddenly as occurs with the step change of a square-wave.

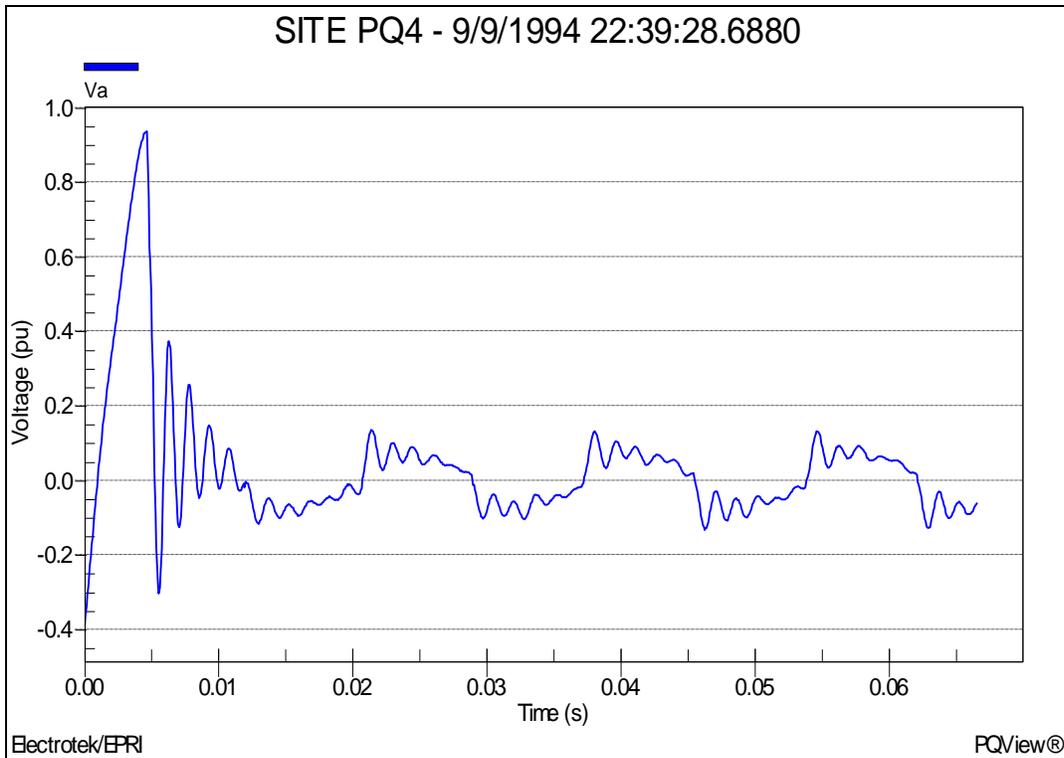
Figure 10 - Illustration of a Voltage Waveform during an Arcing Fault Event

With respect to arcing faults, thunderstorms subject distribution systems to double jeopardy. Not only does the lightning associated with the storm create the potential for flashovers, but the wind associated with the storm increases the chance of tree limb contact. An example of an arcing fault voltage is shown in Figure 10, which shows a measured voltage waveform during an arcing fault on a feeder #3. The fault occurred during a storm that was caused by a tree limb being blown into one phase of the distribution line.

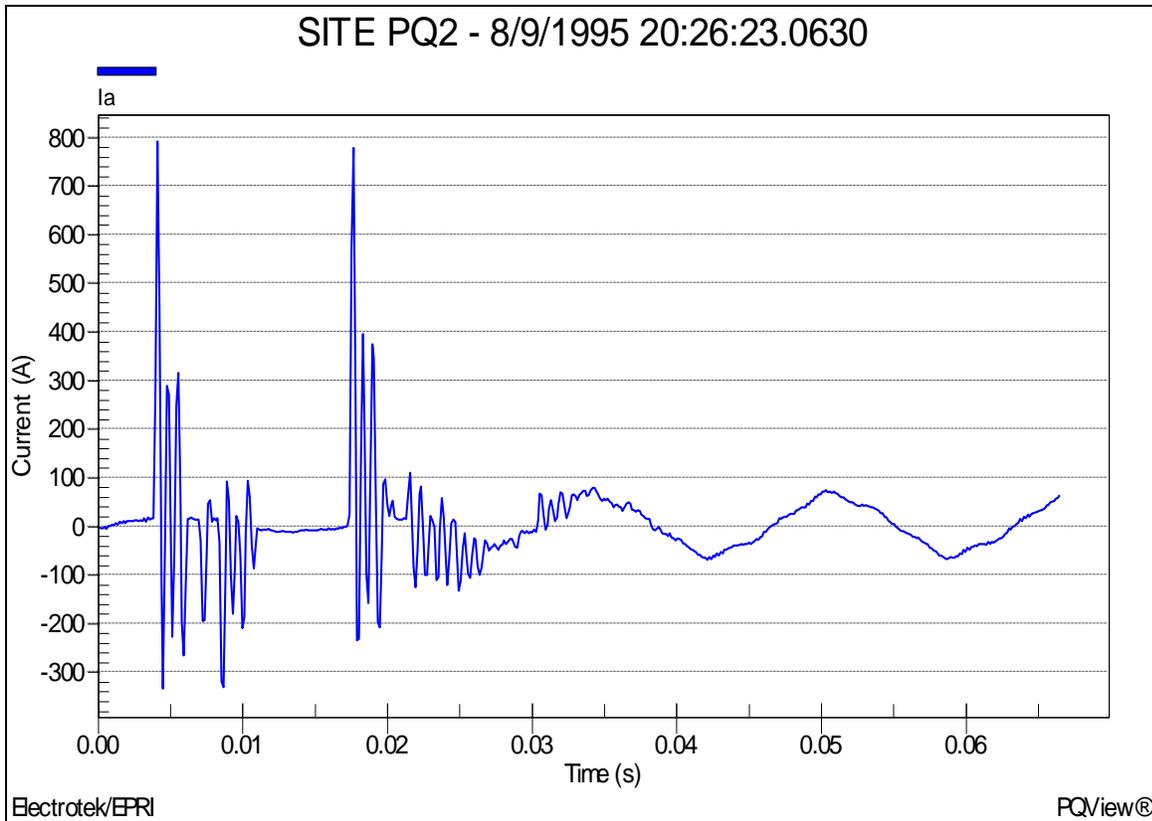
Figure 11 - Illustration of a Current Waveform during a Capacitor Bank Switch Failure

Figure 11 shows the measured current (A) waveform during a capacitor switch failure on feeder #1. The measurement site was PQ2. The maximum transient current magnitude for the event was approximately 790 A. Many similar transient waveforms were recorded at the monitoring site during a one-week period. These events showed that the switch performance had continue to deteriorate.

As the capacitor switch began to fail, abnormal events including arcing and pre-striking occurred. These were the initial warning sign that a more serious failure was about to occur. Closer examination of the waveform indicated that the pole of the switch did not properly close, possibly bouncing. This abnormal event resulted in two distinct energizations. First, the pole bounces, making a connection temporarily, but it does not latch. This results in an arc that extinguishes as the contacts pull apart. As the switch continues to close, however, the pole finally latches, and the capacitor bank was energized.
