PQSoft Case Study

High Neutral-to-Ground Voltages

Document ID:	PQS0401	Date:	March 30, 2004
Customer:	N/A	Status:	Completed
Author:	Electrotek Concepts, Inc.	Access Level	PQSoft Subscriber

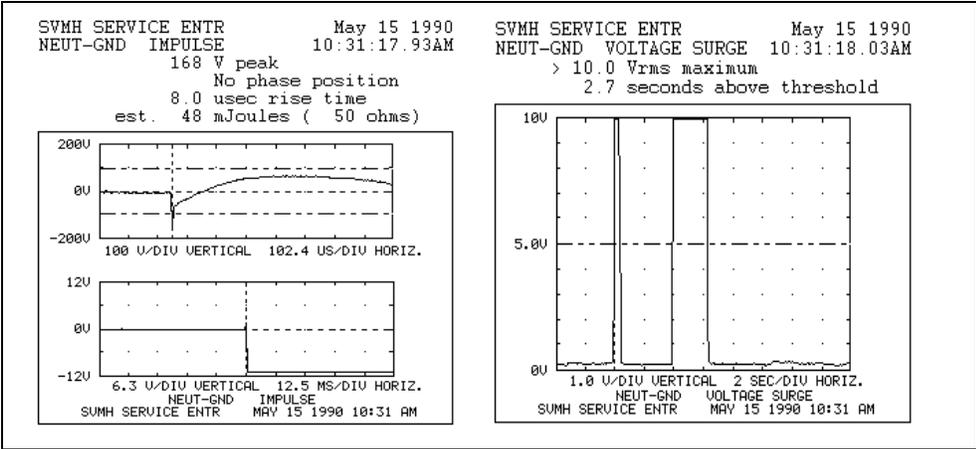
Figure 1 - Disturbance Monitoring Results

A disturbance analyzer was installed at the service entrance to determine if voltage variations such as sags or transients were causing the equipment problems. Figure 1 shows an example of disturbance event that was recorded. During the monitoring period, many neutral-to-ground impulses and surges were recorded at the service entrance. No voltage sags or other events were recorded.

Over the years, vibrations, thermal stresses and building improvements lead to loose connections in wire terminations. On current-carrying conductors, loose connections lead to arcing and sparking and result in high frequency transients. On neutrals, loose connections result in abnormally high or low voltages and result in an unstable reference for highly sensitive electronics.

An infrared heat detector was used to locate loose wiring connections, and once these connections were fixed, the neutral-to-ground voltages disappeared as well as the equipment problems.

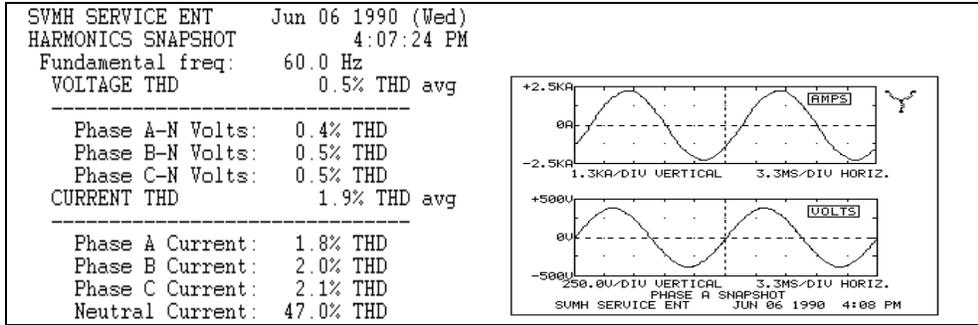
Figure 2 - Harmonic Distortion Results

A spectrum analyzer was also installed at the service entrance to record harmonic distortion levels. Both the voltage and current distortion levels (Figure 2) were very low and should not be causing any equipment problems.
