PQSoft Case Study

PQ Investigation at a Battery Facility

Document ID:	PQS0402	Date:	March 30, 2004
Customer:	Battery Manufacturer	Status:	Completed
Author:	Electrotek Concepts, Inc.	Access Level	PQSoft Subscriber

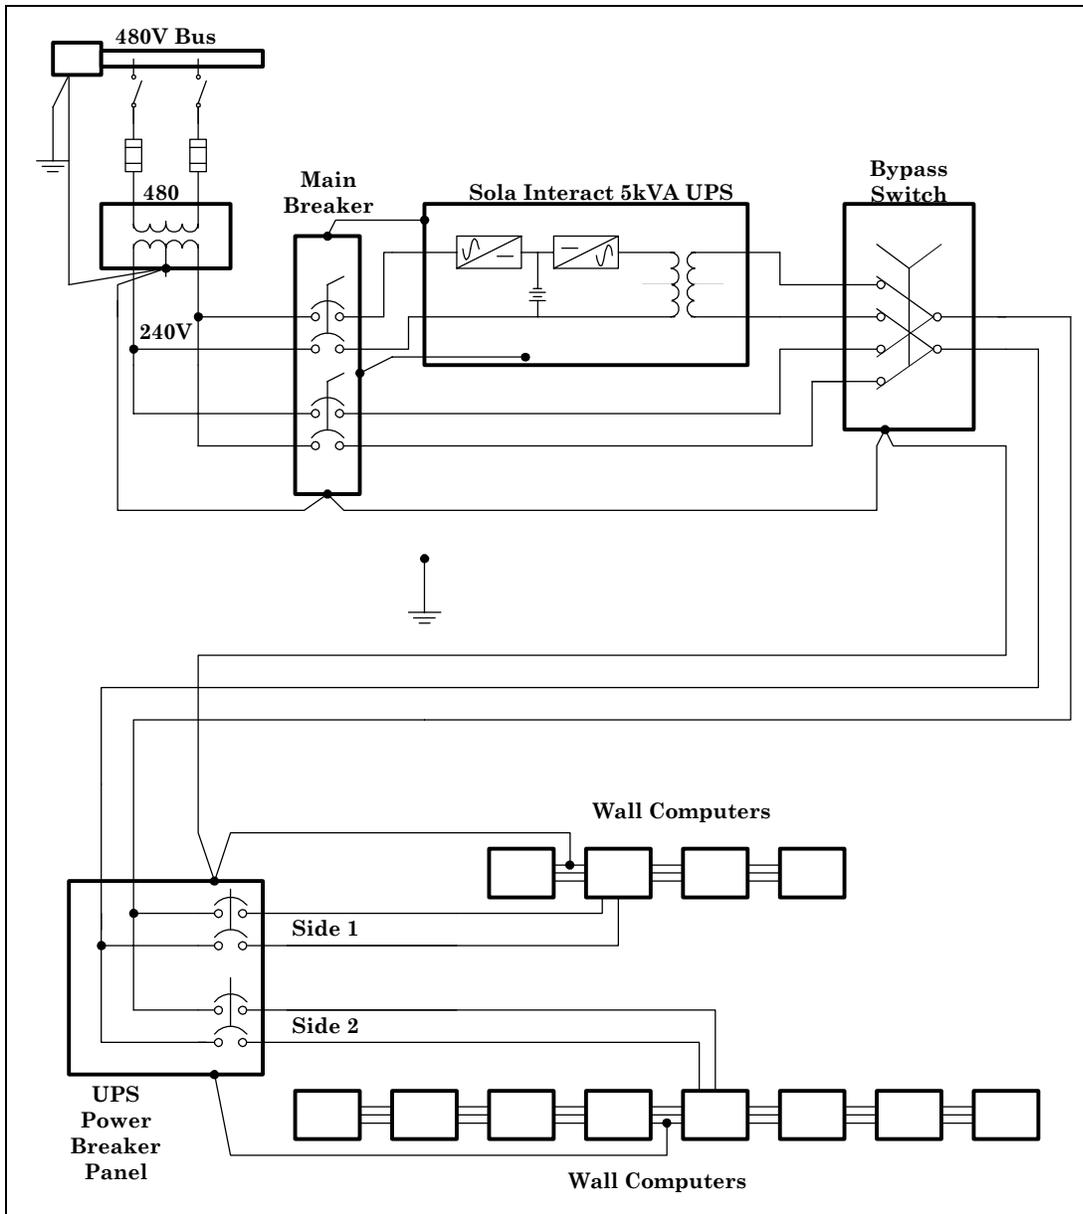
Figure 1 - Powering Arrangements for the Wall Computers

Figure 1 shows how the wall computers are powered. The system lacks a ground reference point -- a single point where all ground wires are connected from. The system would be improved by powering each wall computer from a dedicated circuit, each with an individual ground connection. The improved system would have ground connections run with separate wires that are all tied to a common reference point inside the breaker panel. The common reference point would be a ground bus designed for such a purpose (often a 1/4" copper plate is used).

- Run a separate power circuit and ground wire to each process computer. Have each of the 12 ground wires connected to a common ground bus (1/4” copper plate or similar) and make sure this ground bus is tied to building steel, and to the ground lug at the 480V bus duct.
- Tie the shield (of the cable from the current sensor board) to ground at both ends. This will restore the electromagnetic shielding. Do not connect it directly to data common. Assure it has good contact with building steel, via conduit, etc.

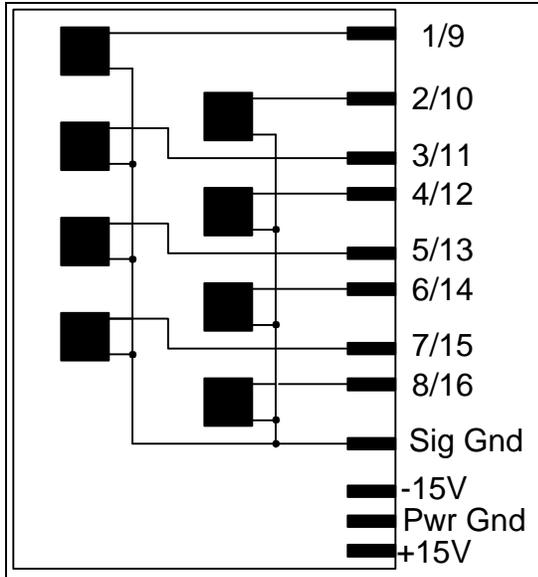
Figure 2 - Current Sensor Board with Shared Signal Return

Figure 2 depicts the current sensor board. The board is used for eight Hall Effect transducers to monitor the current of eight circuits. The board is designed with a signal common for all the signal transducers. Bench tests indicate that the transducers appear to be accurate within 0.5%. However, those tests show that the signal common causes the reference to be corrupted, such that the accuracy of this board is only within about 5%, and the errors are not consistent.

An improved design of this board would have separate commons for all of the eight signals. Twisted-pair, shielded cable would offer the best immunity for electromagnetic and electric field interference. The shield of the cable should be grounded at both ends, to ensure the integrity of an alternative path (rather than through the signal conductors) for electromagnetic interference. The shield of the cable should be tied to the grounding of enclosures, etc., and not to the logic common. Where possible, the logic common of the system should be isolated from the safety grounding system.

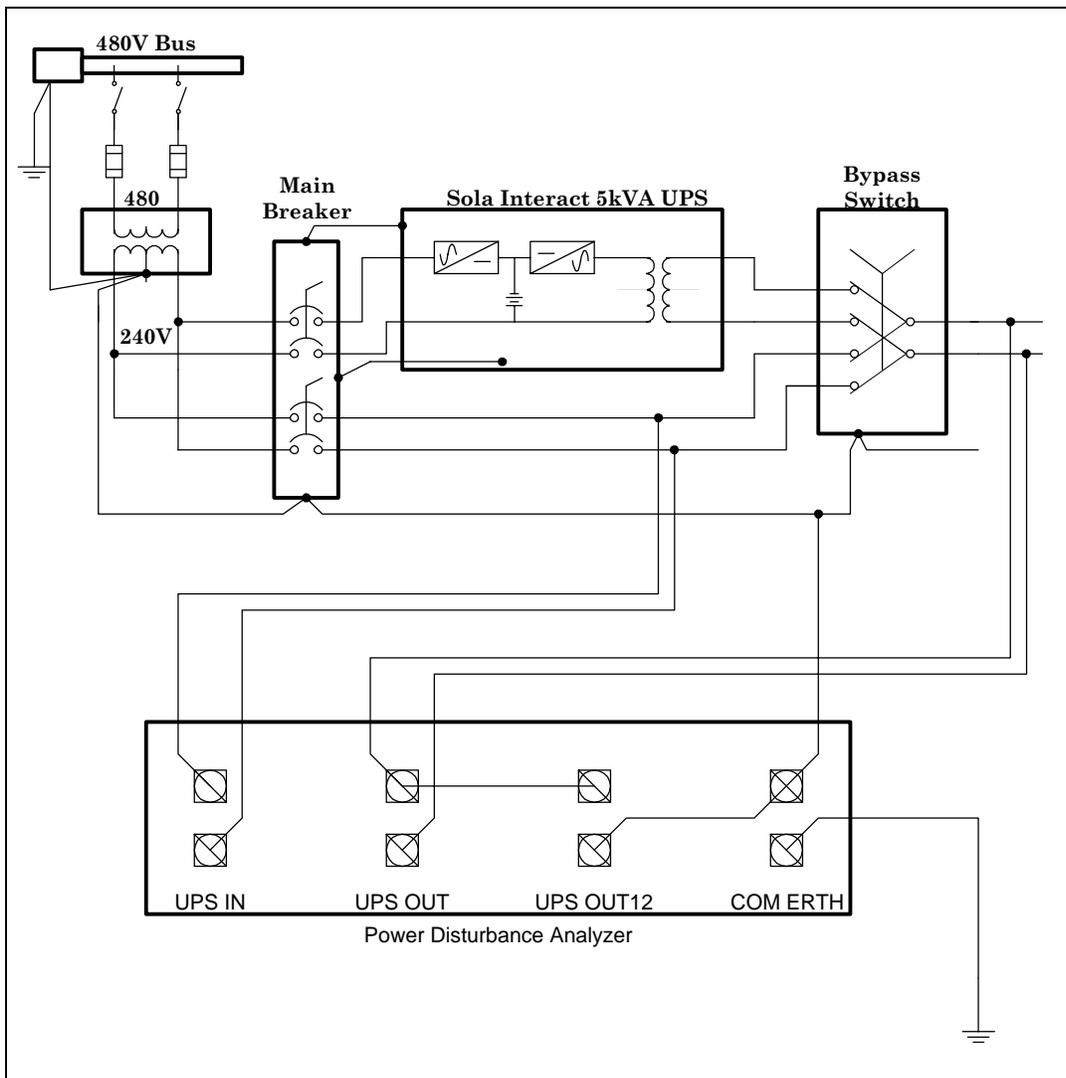
Figure 3 - Power Disturbance Analyzer Connections

A BMI power disturbance analyzer was connected to the system as shown in Figure 3. The purpose of this connection was to determine if there was noise on power (channels 1-2) and the data common signal (channels 3-4). Also the analyzer provides “time stamping” of any disturbances that might be correlated with any operation difficulties of the system.

Table 2 summarizes some of the early results from the disturbance analyzer. The levels recorded should be considered normal. It is important to note that the signal common-to-earth voltage remained at a very low level. Should a ground fault interfere with the signal common, this should show up on this measurement.
