PQSoft Case Study

Substation Voltage Flicker Data Analysis

Document ID:	PQS1208	Date:	June 4, 2012
Customer:	N/A	Status:	Completed
Author:	Electrotek Concepts, Inc.	Access Level:	PQSoft Subscriber

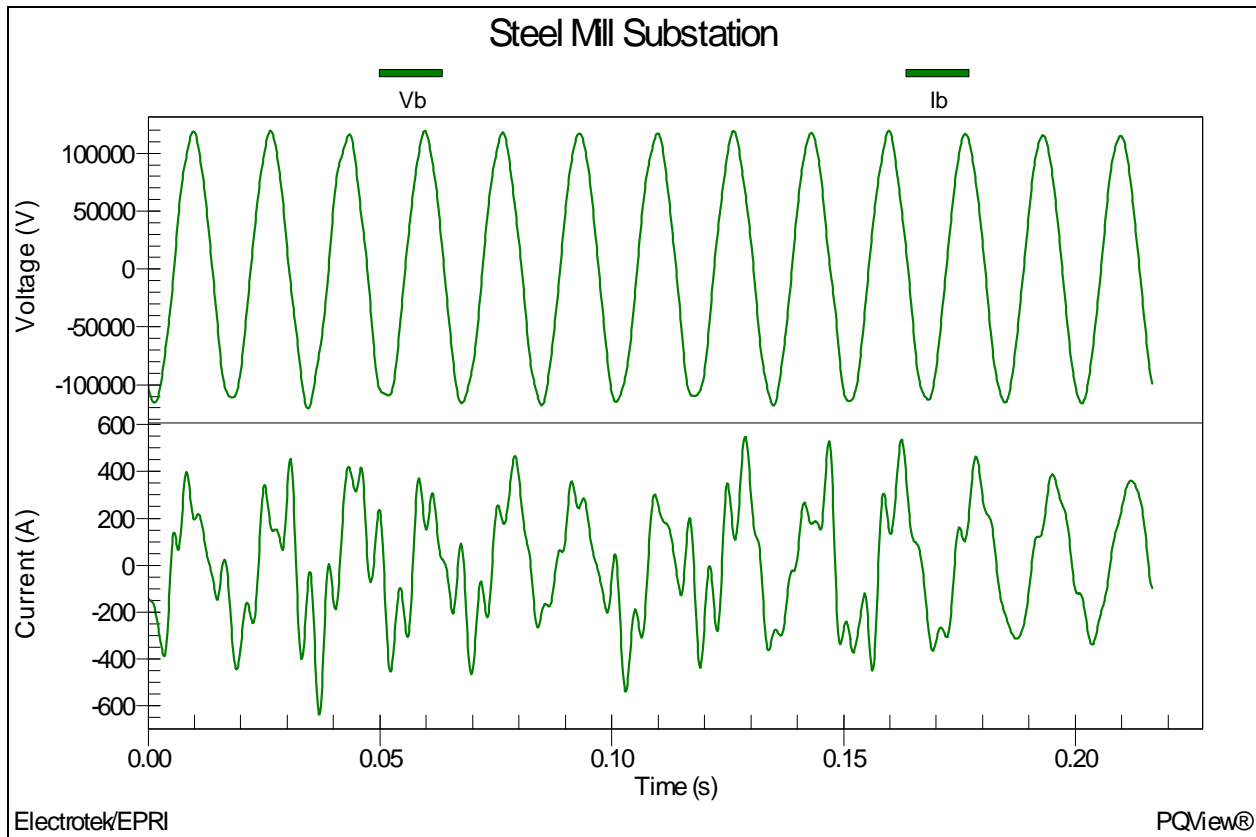
Figure 2 - Steel Mill Substation Representative Voltage and Current Waveforms

Figure 2 shows a representative voltage and current waveform measured at the point of common coupling (PCC) 138kV transformer primary in the Steel Mill Substation. The fundamental frequency phase-to-ground voltage was 81.657kV (1.03 per-unit), the rms voltage was 81.703kV, and the total harmonic voltage distortion (V_{THD}) was 1.86%. The fundamental frequency current was 208.8 A, the rms current was 251.7 A, and the current distortion (I_{THD}) was 33.16%.

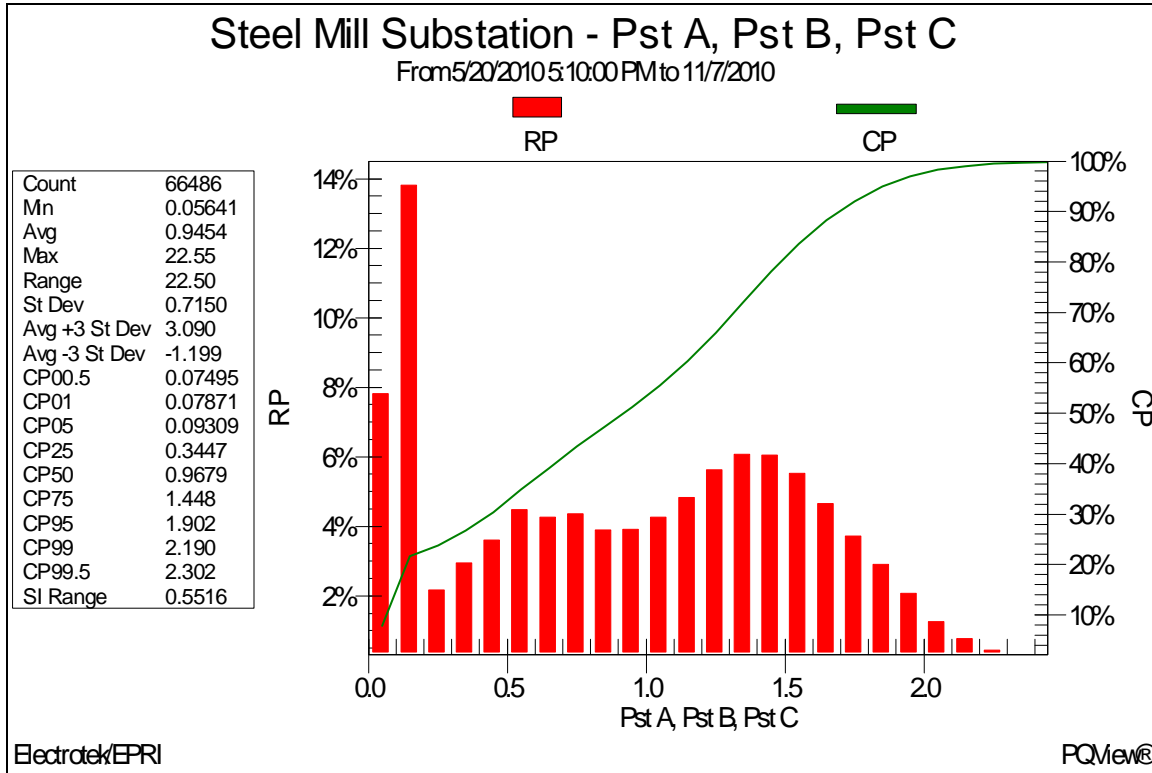
Figure 3 - Steel Mill Substation Histogram of Voltage Flicker Values

Figure 3 shows the three-phase voltage flicker P_{st} histogram measured at the 138kV Steel Mill Substation for the entire monitoring period. Statistical analysis of the 66,486 individual steady-state measurements yielded a CP50 value of 0.97, a CP95 value of 1.90, and a CP99 value of 2.19. The results show that the CP99 compatibility limit of 1.0 is exceeded. Note that CP95 refers to the cumulative probability, 95th percentile of a value.

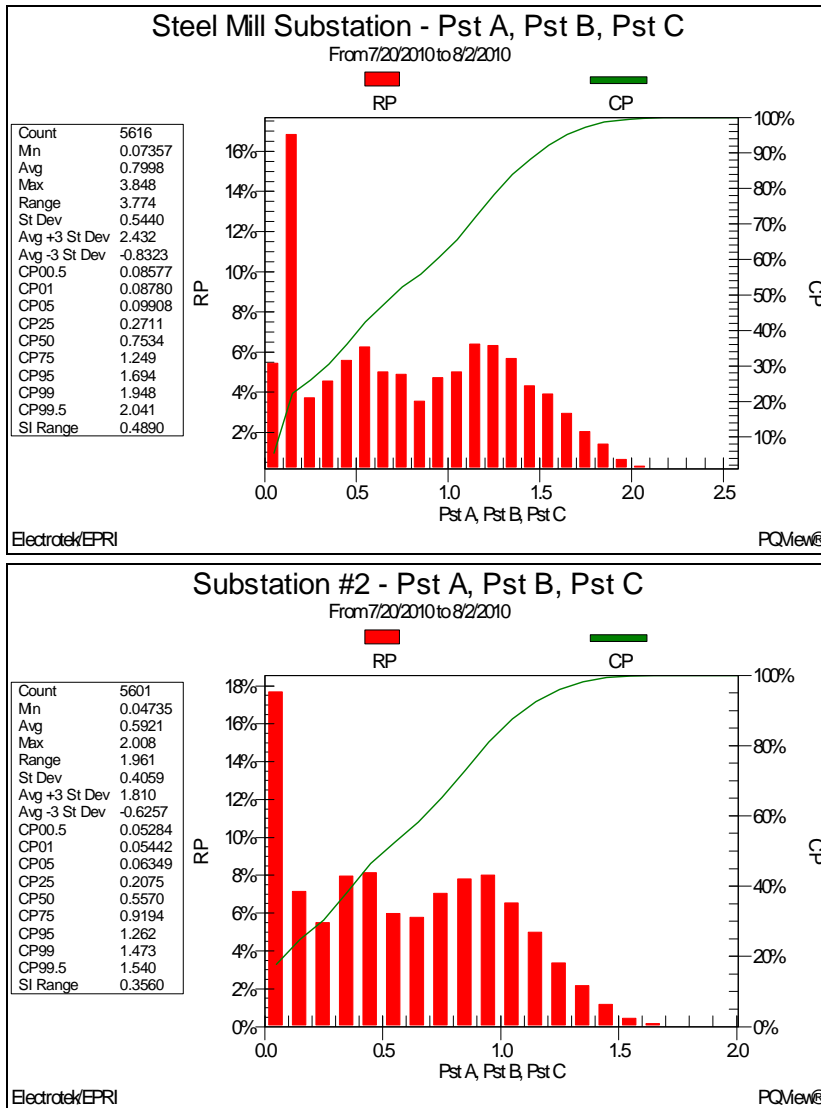
Figure 4 - Steel Mill Substation and Substation 2 Voltage Flicker Values

Figure 4 shows the three-phase voltage flicker P_{st} histograms measured at the 138kV Steel Mill Substation and at Substation #2. The results for the Steel Mill Substation included a CP50 of 0.75, a CP95 value of 1.69, and a CP99 value of 1.95. The results for Substation #2 included a CP50 of 0.56, a CP95 value of 1.26, and a CP99 value of 1.47.

Location	CP50	CP95	CP99
Steel Mill Substation	0.75	1.69	1.95
Substation #2	0.56	1.26	1.47
Flicker Transfer Factor	0.75	0.75	0.75

The CP99 flicker transfer factor of 0.75 indicates that Substation #2 sees 75% of the flicker produced by the arc furnace at the Steel Mill Substation.

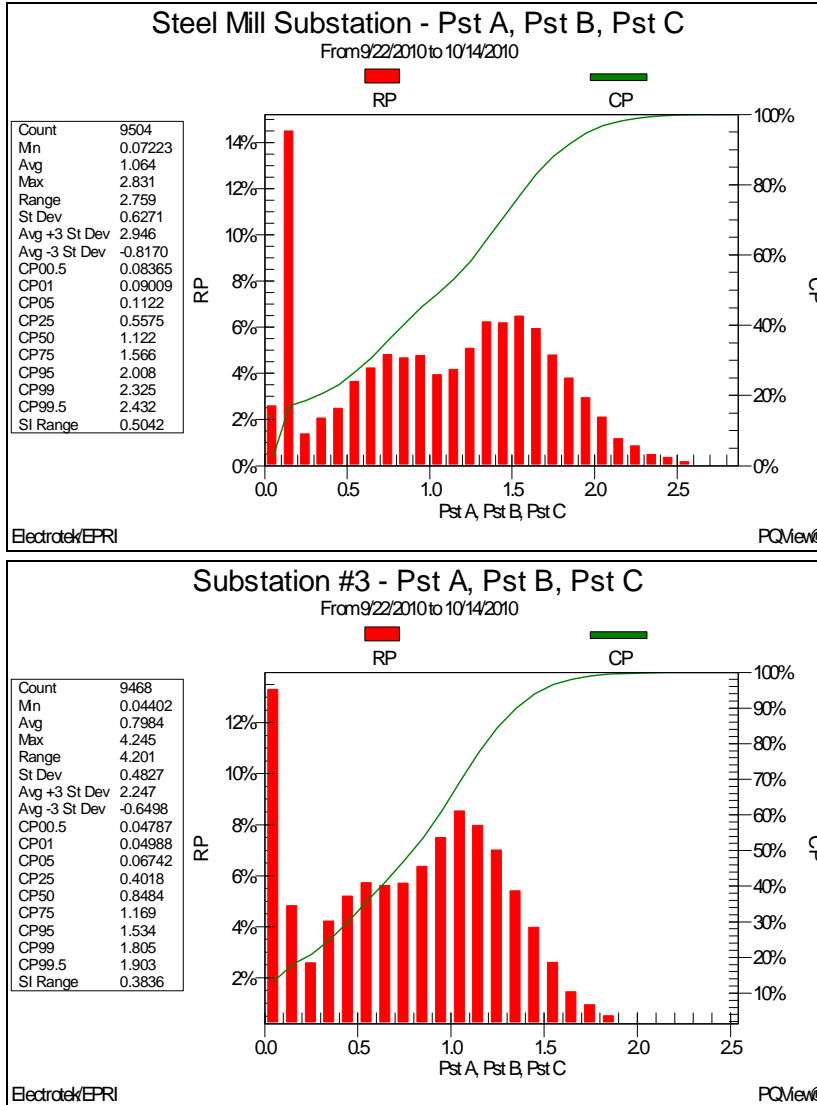
Figure 5 - Steel Mill Substation and Substation 3 Voltage Flicker Values

Figure 5 shows the three-phase voltage flicker P_{st} histograms measured at the 138kV Steel Mill Substation and at Substation #3. The results for the Steel Mill Substation included a CP50 of 1.12, a CP95 value of 2.01, and a CP99 value of 2.33. The results for Substation #3 included a CP50 of 0.85, a CP95 value of 1.53, and a CP99 value of 1.81.

Location	CP50	CP95	CP99
Steel Mill Substation	1.12	2.01	2.33
Substation #3	0.85	1.53	1.81
Flicker Transfer Factor	0.76	0.76	0.78

The CP99 flicker transfer factor of 0.78 indicates that Substation #3 sees 78% of the flicker produced by the arc furnace at the Steel Mill Substation.

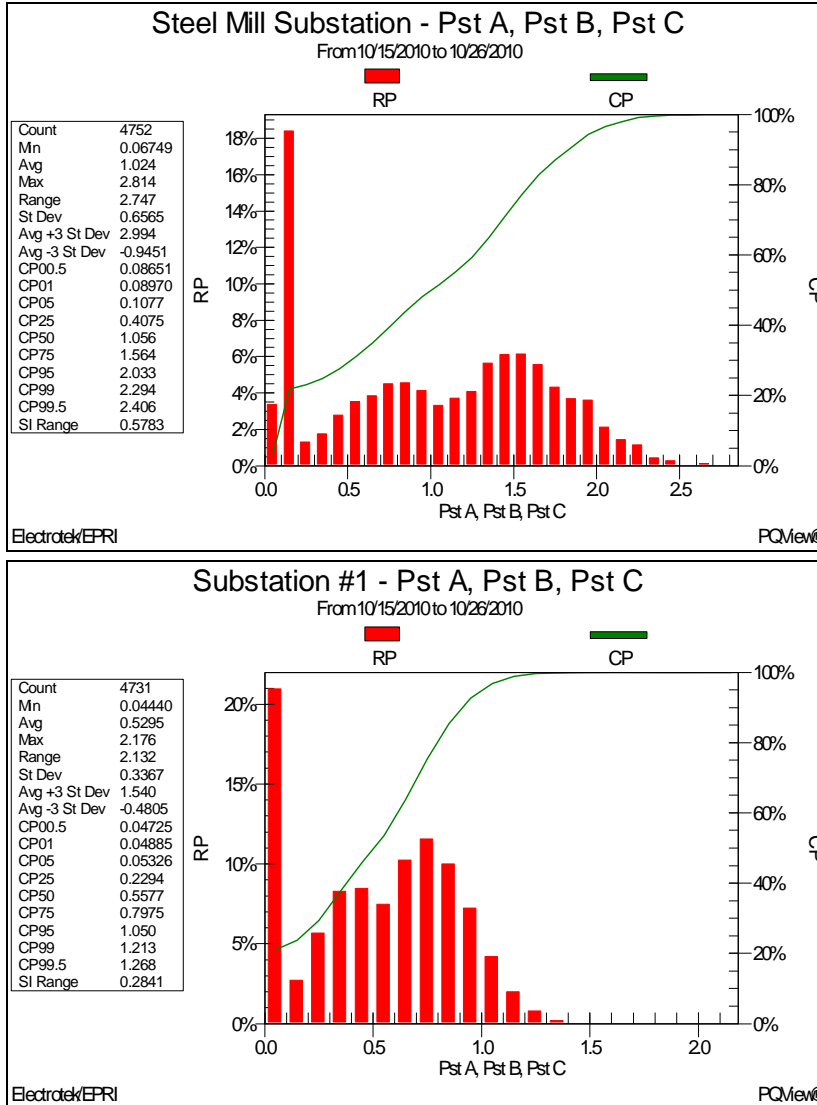
Figure 6 - Steel Mill Substation and Substation 1 Voltage Flicker Values

Figure 6 shows the three-phase voltage flicker P_{st} histograms measured at the 138kV Steel Mill Substation and at Substation #1. The results for the Steel Mill Substation included a CP50 of 1.06, a CP95 value of 2.03, and a CP99 value of 2.29. The results for Substation #1 included a CP50 of 0.56, a CP95 value of 1.05, and a CP99 value of 1.21.

Location	CP50	CP95	CP99
Steel Mill Substation	1.06	2.03	2.29
Substation #1	0.56	1.05	1.21
Flicker Transfer Factor	0.53	0.52	0.53

The CP99 flicker transfer factor of 0.78 indicates that Substation #1 sees 53% of the flicker produced by the arc furnace at the Steel Mill Substation.
